SCIENCE EXPLORE-An International Journal on Science and Knowledge in General

## FLOOD ACTIONS AND STRUCTURAL RESPONSE OF A G+4 REINFORCED CONCRETE BUILDING IN SPECIAL FLOOD HAZARD AREAS

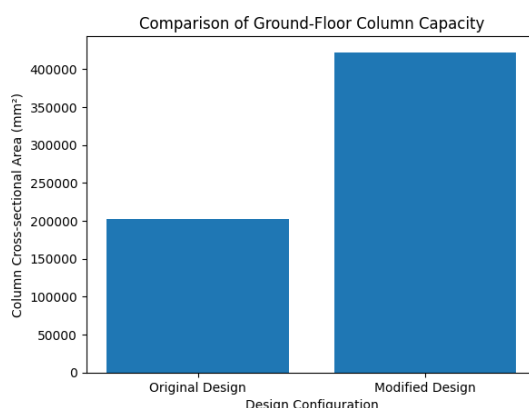
**Chart: Comparison of Ground-Floor Column Capacity**

From above Figure presents a comparative bar chart illustrating the increase in ground-floor column cross-sectional area between the original and modified structural designs. The original design employed columns of size 450 × 450 mm, whereas the redesigned configuration adopted enlarged columns of 650 × 650 mm to improve flood resistance.

The comparative chart highlights a substantial increase in the load-carrying capacity of the ground-floor columns following the proposed structural modifications. In the original design,

the column cross-sectional area was 202,500 mm<sup>2</sup>, which proved inadequate to resist the elevated axial forces and bending moments induced by combined hydrostatic, hydrodynamic, and debris impact loads during flood conditions. In contrast, the modified design increased the column size to 650 × 650 mm, resulting in a cross-sectional area of 422,500 mm<sup>2</sup>—more than a 100% increase compared to the original configuration. This geometric enhancement significantly improves stress distribution, reduces demand-to-capacity ratios, and enhances overall structural stiffness at the base level, where flood-induced forces are most critical. When combined with the upgrade in concrete grade from M25 to M30 and an increased reinforcement ratio using Fe 415 steel, the redesigned columns exhibit improved strength, durability, and ductility, thereby ensuring a resilient structural response under extreme flood loading scenarios.

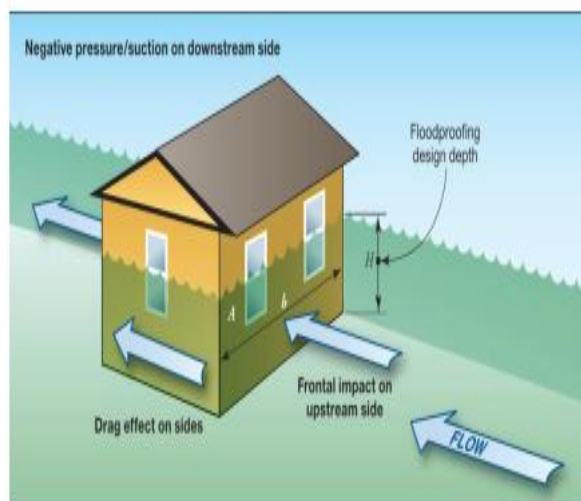
Fig: Hydrodynamic and impact forces

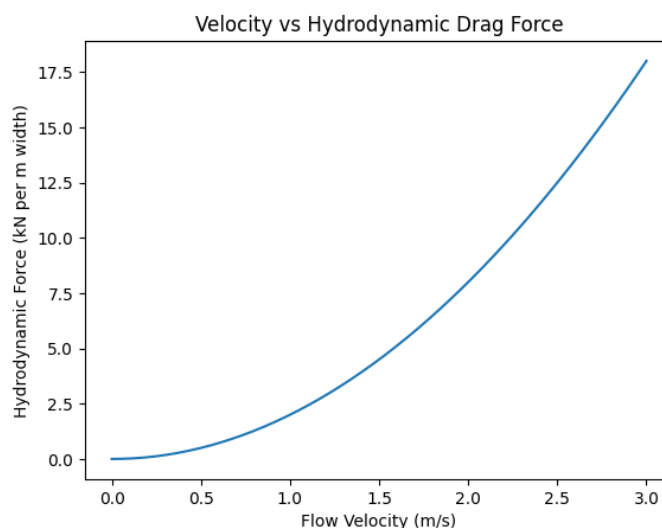
Fig. 7 Relationship between floodwater velocity and hydrodynamic drag force acting on the structure.

Figure 7 presents the relationship between flow velocity and the resulting hydrodynamic drag force acting on the structure. The graph demonstrates a nonlinear, quadratic increase in hydrodynamic force with increasing flow velocity, as the drag force is proportional to the square of the velocity. Even moderate increases in floodwater velocity result in a disproportionately large rise in lateral force demand on the building façade. At

higher velocities, the hydrodynamic force becomes comparable to or greater than hydrostatic forces, significantly amplifying bending moments and axial stresses in structural members. This behavior highlights the critical importance of incorporating velocity-dependent hydrodynamic effects in flood-resistant structural design, particularly for buildings located in Special Flood Hazard Areas.
